== USS O'BANNON (DD-987) ==
SEMAT I SHELL CONDITION ASSESSMENT
SURVEY
INTERIOR AREAS
11/10/01 TO 11/21/01

PREPARED BY
SUPERVISOR OF SHIPBUILDING CONVERSION
AND
REPAIR
PORTSMOUTH, VIRGINIA
11/26/01

USS O'BANNON (DD-987)
SHELL CONDITION ASSESSMENT SURVEY, INTERIOR AREAS.

A SEMAT I UNDERWATER HULL AND SUPPORTING STRUCTURE SURVEY OF INTERIOR AREAS WAS CONDUCTED ON BOARD **USS O'BANNON (DD-987)** FROM 11/09/01 TO 11/21/01 AT ATLANTIC DRYDOCK CORPORATION JACKSONVILLE FLORIDA.

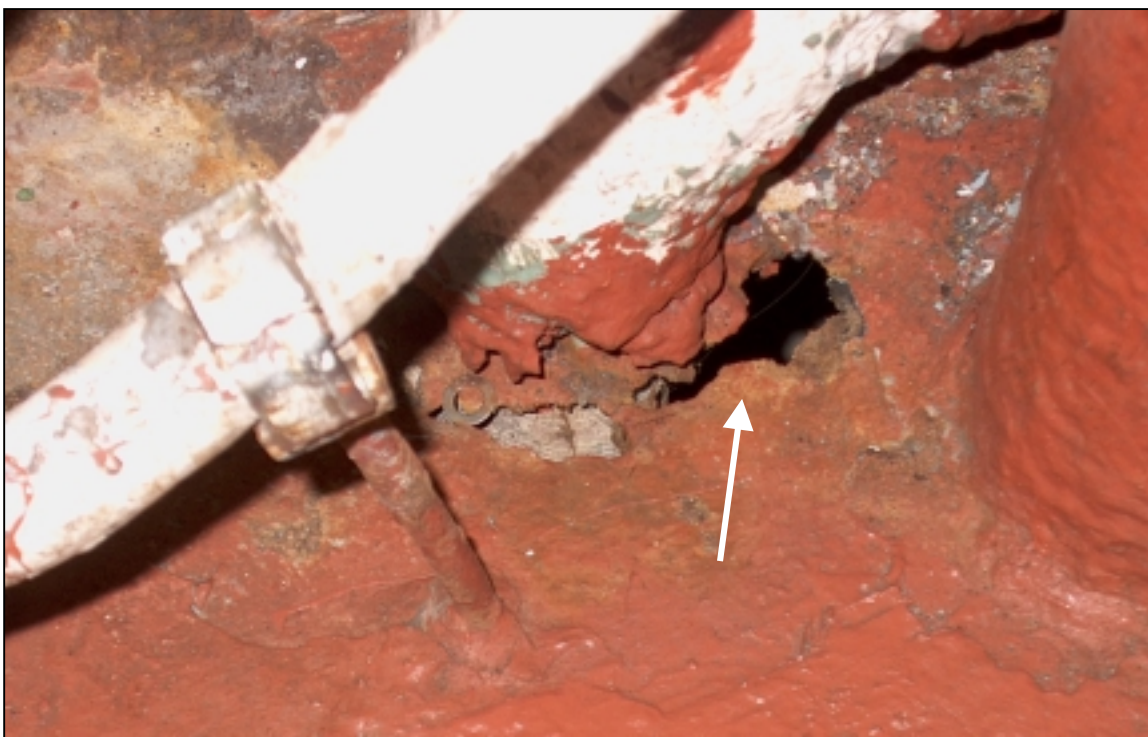
UPPER LEVEL PORT SIDE OF LUBE OIL STORAGE TANK (2-316-6-F)
ARROW INDICATES HOLE IN DECK. JSN # 5787

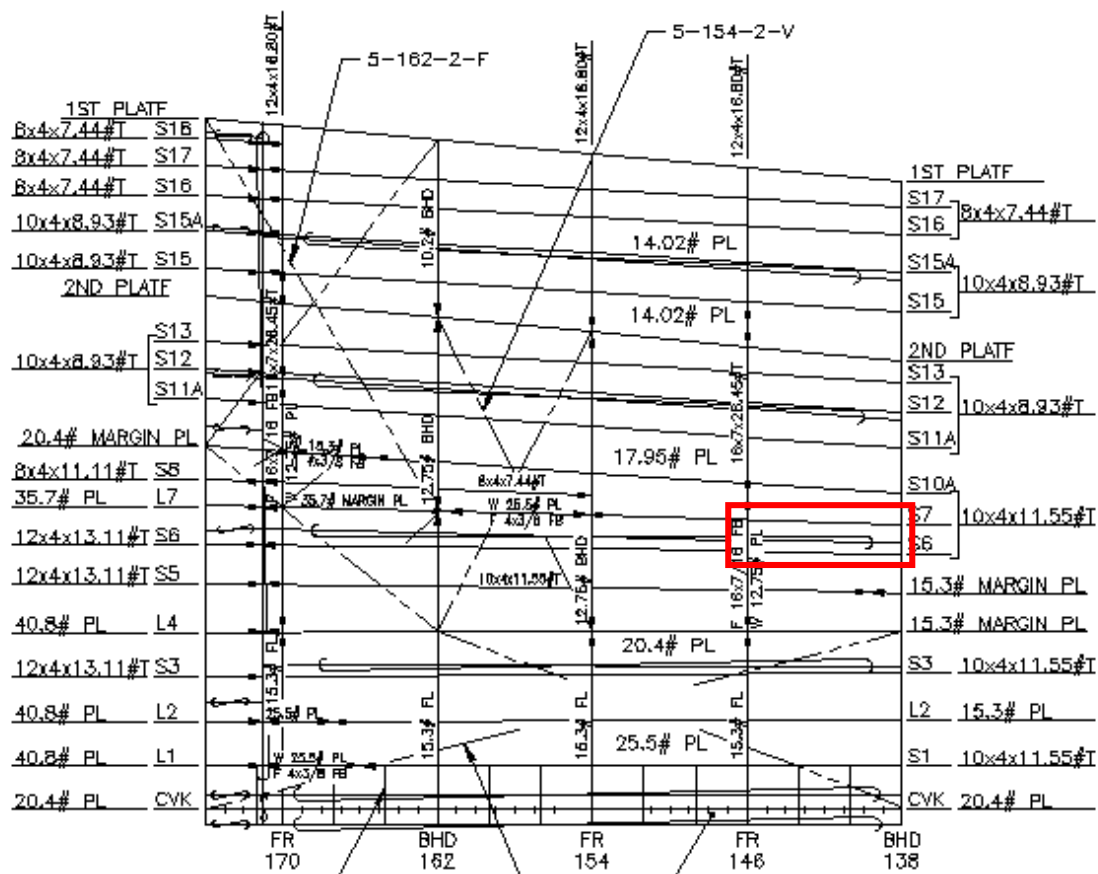
FORWARD PUMP ROOM / SEWAGE PLANT NO. 1 (5-138-0-Q)

STARBOARD SIDE, WEB OF STRINGER (6) IS SEVERELY DETERIORATED, APPROXIMATELY 46" AFT OF BULKHEAD (138), SEE DRAWING FOR U/T READINGS OF SURROUNDING AREA.

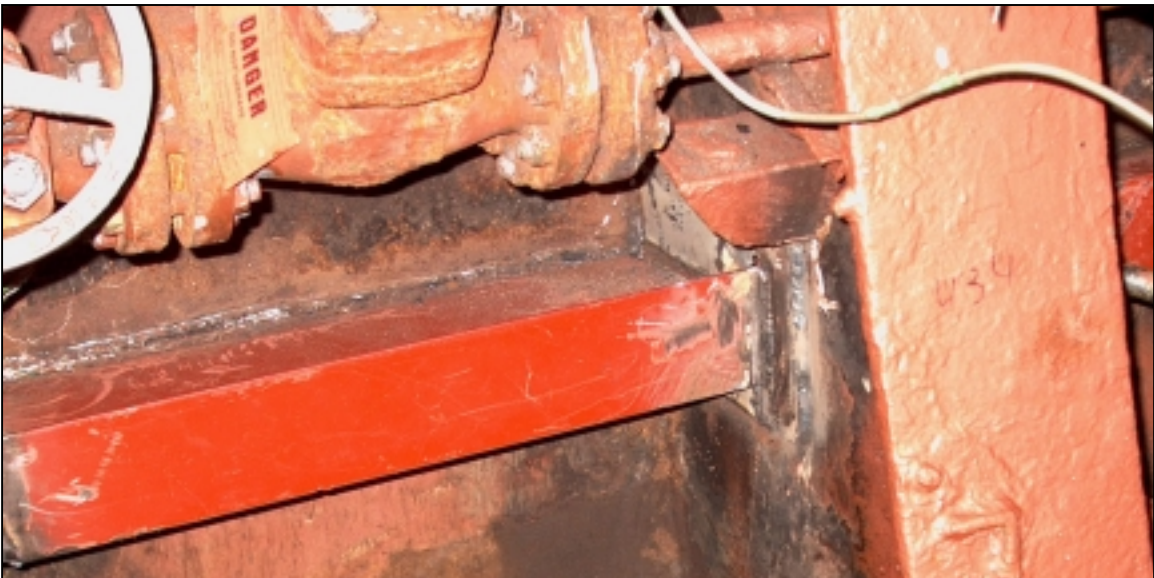
STRINGER REPAIRS JSN # 5545
